'€1 million per micron' – assessing the quality of superyacht finishes

Alan Guy, director of technology at coatings specialist and engineering consultant Safinah Group, considers some of the challenges related to paint finishes on superyachts – and in particular, how best to mitigate the 'orange peel' effect

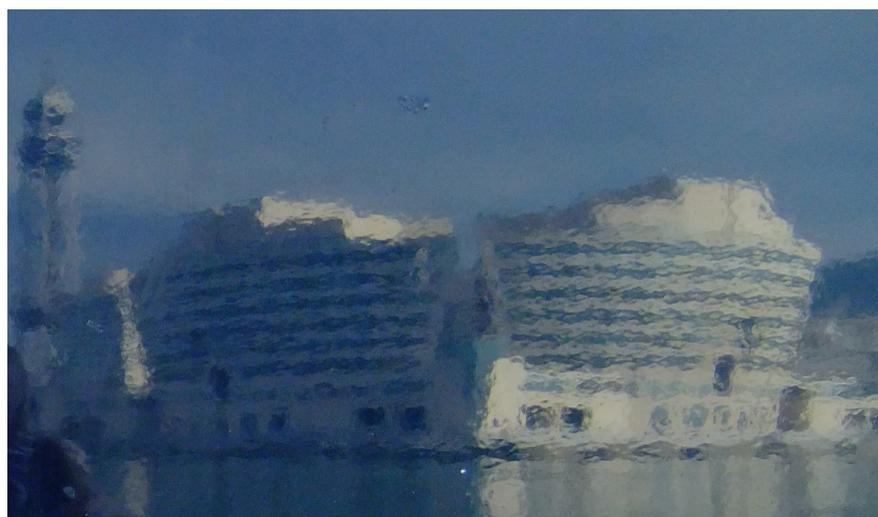
Figure 1: Example of the effect of 'orange peel'

Several authors have discussed the factors that when combined contribute to a 'good' finish [1]. In Safinah's experience, assuming that the paint finish is free of other defects such as sags, runs, excessive dust inclusions and fisheyes, etc, there is rarely a problem with gloss levels. The aspect that causes most debate is the residual structure, or 'waviness', known as 'orange peel'. Reflections from 'peely' surfaces appear 'pixelated', as shown in Figure 1.
